NON-DESTRUCTIVE INSPECTION FOR INTERNAL GUY CORROSION ON TALL TOWERS

Robert F. Zueck, PhD, PE
Naval Facilities Command
Engineering Service Center
1100 23rd Ave
Port Hueneme, CA 93010

ABSTRACT

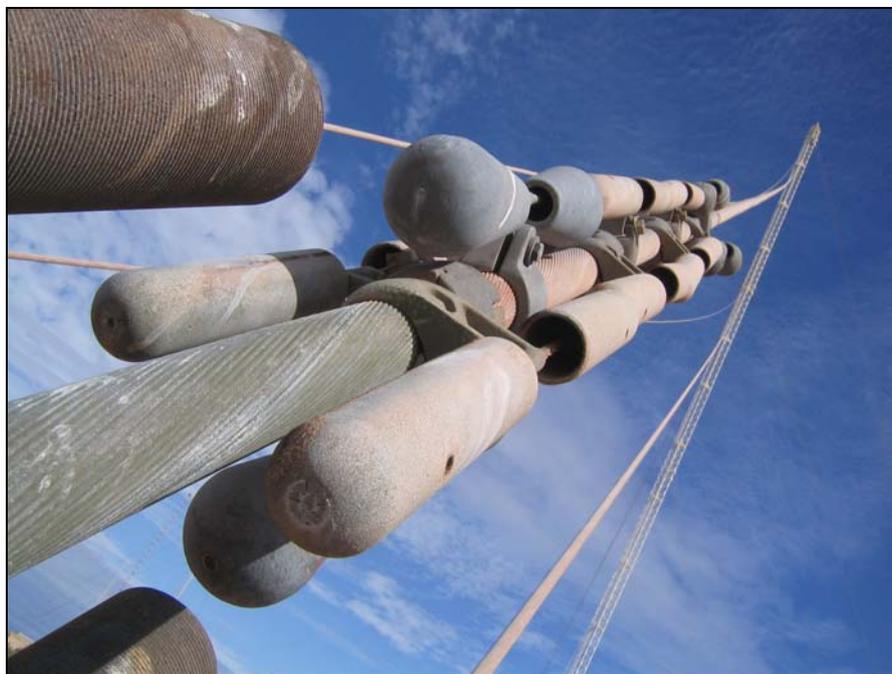
Showing external signs of significant corrosion, the guys supporting the FSBS antenna at Harold E. Holt Naval Communications Station in Western Australia (HEH) are the first in need of replacement. Shown in figure 1, the typical guy at HEH is between 250 and 2000 feet (75 to 600 m) in length and made principally of structural strand that can be 1 to 4 inches (25 to 100 mm) in diameter. The wires are helically twisted and laid in low-pitch angles around each other. This helical lay tightens the bundle of wires and allows for some curvature along its length. In contrast to structural strand, wire ropes have a high-pitch angle so that they can be bent sharply around running sheaves.

FIGURE 1 - Typical guy supporting slender tower with vibration dampers at lower end

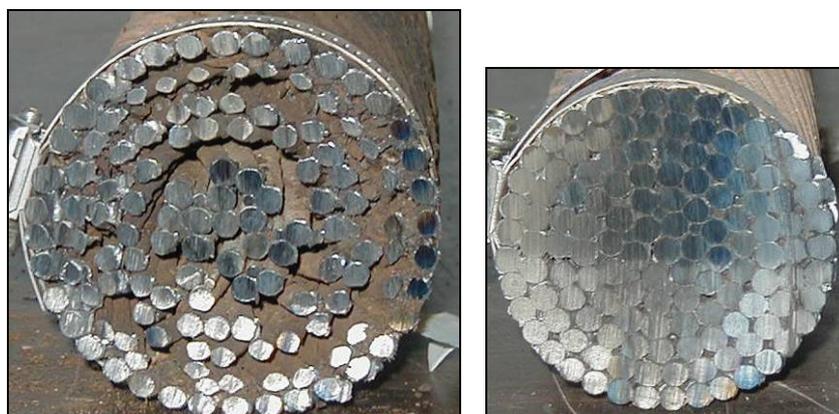
Of the few guys replaced at HEH so far, forensic investigations indicate that some were not near failure, while others were very near failure. Figure 2 compares severely corroded cross-section with an uncorroded one on the same guy. Maximum Loss of the cross-sectional Metallic Area (LMA) is about 47%, with an even greater loss of structural strength. Note that the outside surface of this guy shows little if any corrosion in either the corroded or uncorroded sections.

FIGURE 2 - Comparison of internally corroded versus uncorroded sections of same guy

Since structural strand is designed to have little or no movement between wires, individual wires of a structural strand are protected from corrosion by a hot-dipped zinc galvanized coating. Heavier

galvanization on the outer layer of wires is protecting outer wires longer, sealing in moisture and promoting corrosion of internal wires, which have thinner galvanized coating. Because internal wires are more active in tension than the outer wires, detection of corrosion on internal wires is critical.

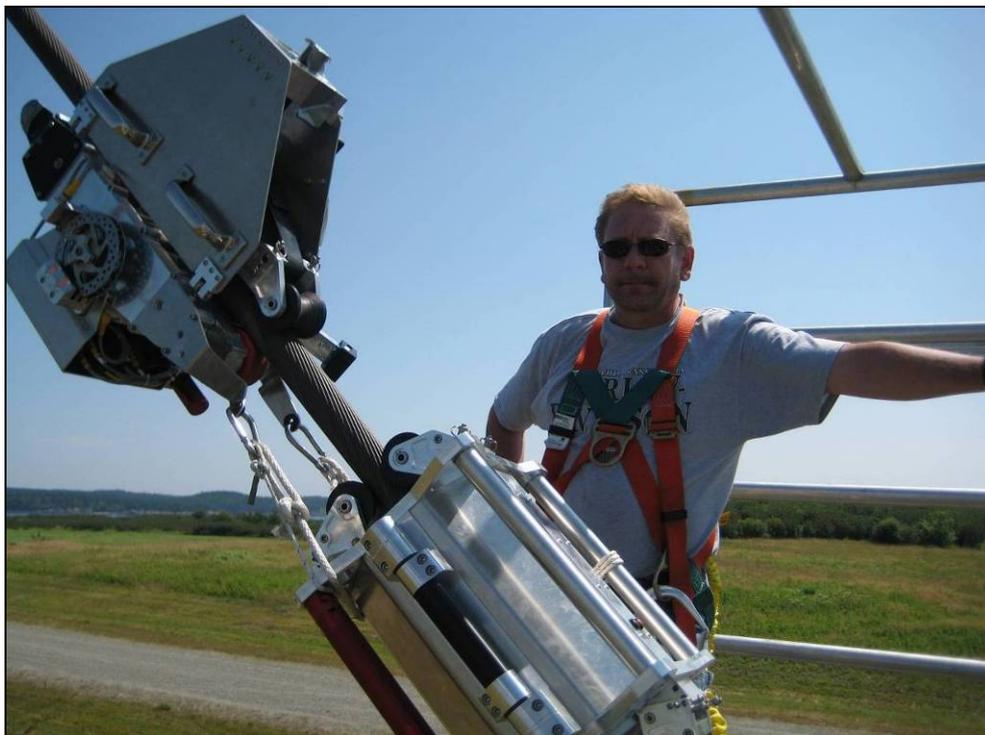
As part of a larger phased research, developmental, testing and evaluation effort, three small-scale concepts and one small diameter prototype guy inspection tool were built and tested by three different contractors³. Afterwards, a prototype large-diameter guy inspection tool was designed and built⁴, as shown in figure 4. This tool consisted of a magnetizing sensor head hitched to a powered guy crawler, with a portable computer wirelessly controlling both.

FIGURE 4 - Guy Crawler towing magnetizing sensor head on tower guy

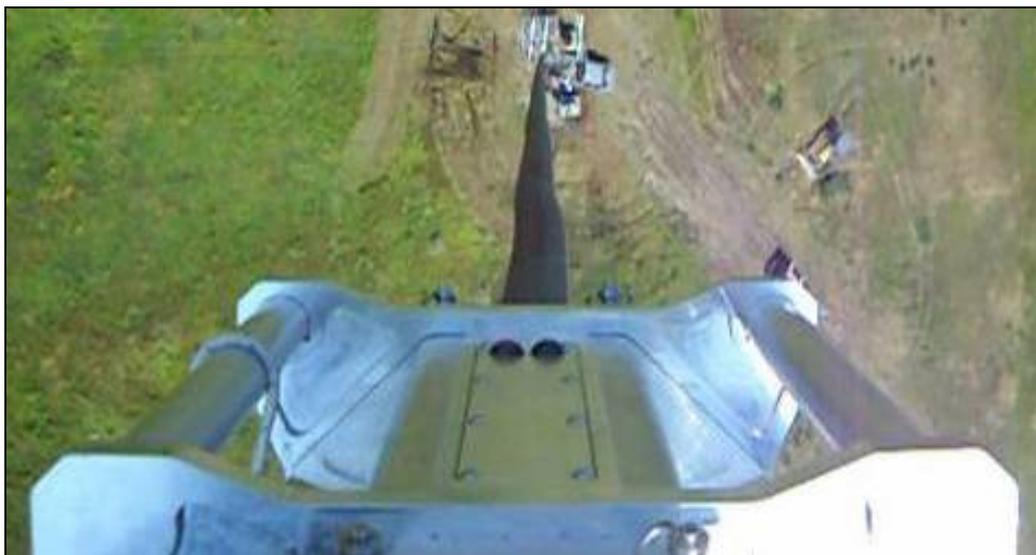
Figure 7 shows a view from the rear of the crawler looking below the towed magnetizing sensor head at a corkscrew deformation on one of the and longest length guys at Cutler. Corrosion of internal wires is only one of many possible causes for such a structural deformation.

FIGURE 7 - View from the rear of the robotic crawler about half way up the guy

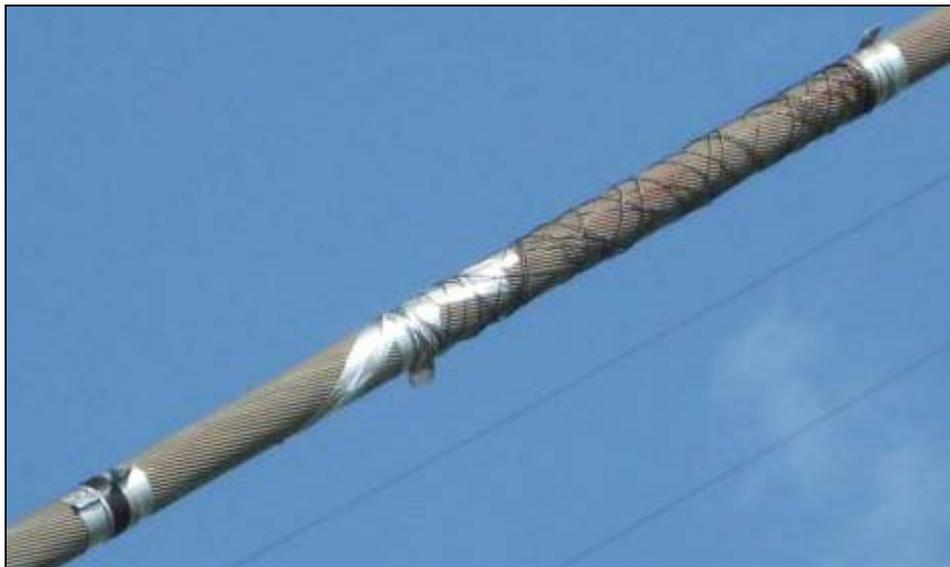
Since guy corrosion is not yet an issue at Cutler, the measured signal showed no obvious signs of corrosion along the large diameter guy used for testing. In order to check that the tool was correctly measuring LMA, artificial defects were added to the guy. As shown in figure 8, a short and long artificial defect was added in two different locations by wrapping rebar tie wire around the guy. Measuring the gain of cross-sectional metallic area from the added defects is essentially equivalent to measuring a similar level of LMA, while remaining non-destructive to the guy.

FIGURE 8 - Artificial defects added to the guy for testing tool sensitivity
